TECHNICAL MEMORANDUM 226

ROCKET SLED IMPACT TESTS
OF BULK CONTAINERS FOR ETIOLOGIC
AGENT STORAGE AND SHIPPING

ROCKET SLED IMPACT TESTS OF BULK CONTAINERS
FOR ETIOLOGIC AGENT STORAGE AND SHIPPING

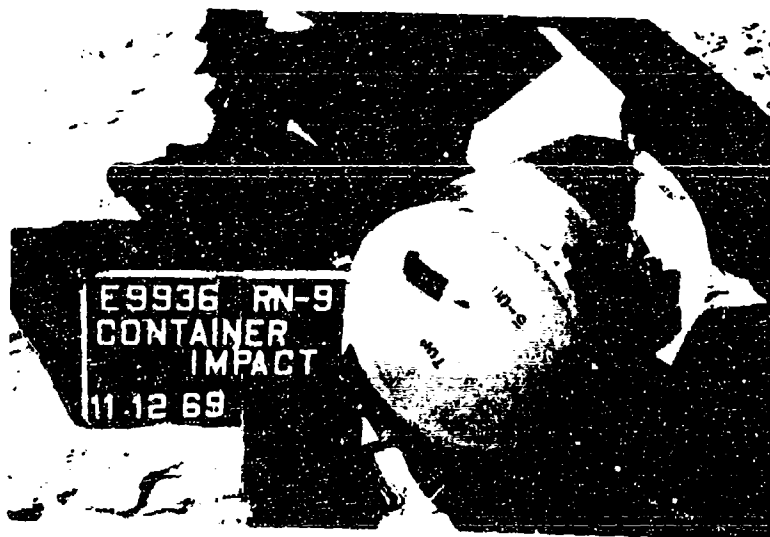
FIGURE 7. Test Item After Impact Showing
Accelerometer Still in Place.

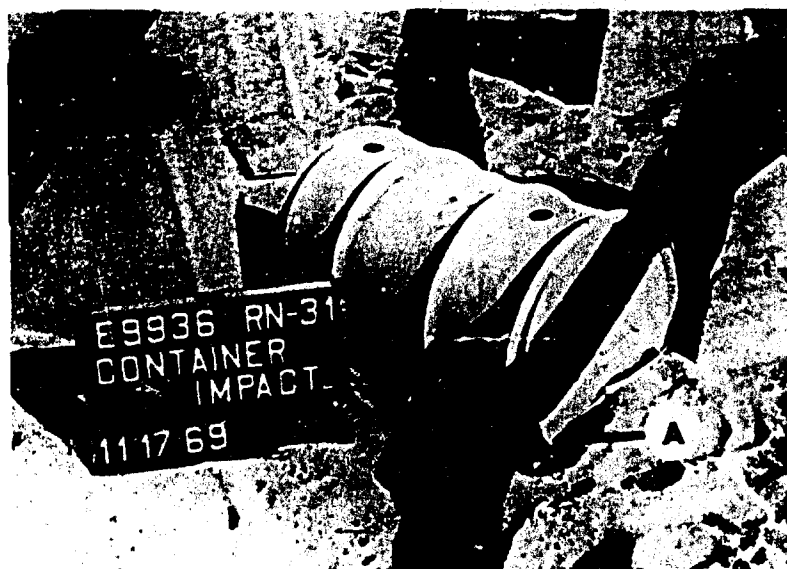
FIGURE 13. Five-Gallon System at Rest After Side Impact. A - area of leak.

Damage is most severe when cylindrical container systems are impacted with their sides oriented parallel to the target. First of all, attachment of test items to the sled in this attitude to insure positive release at moment of impact is difficult and, although several variations were tried, "hang-ups" did occur. Of the four cylindrical, side-impacted test items that failed to meet the test criteria, three were fouled by attachment cables. The leaks, however, were limited to a liquid trickle from a narrow separation of outer drum covers at a point where body chimes were flattened by the side impact. In no case was there any splatter about the target area and the leakage did not commence until containers came to rest after impact action. Figure 13 shows a typical leak for systems of this size that sustained a side impact.

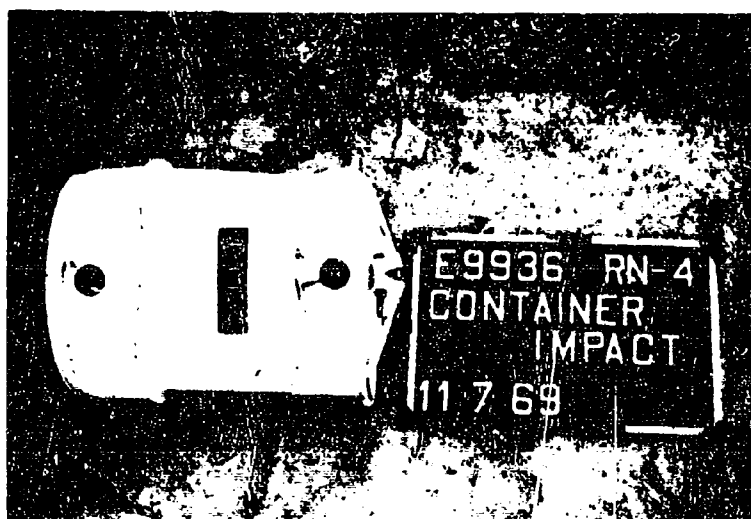
FIGURE 16. Typical Damage to the 1-gal System Bearing Impact on the Top.

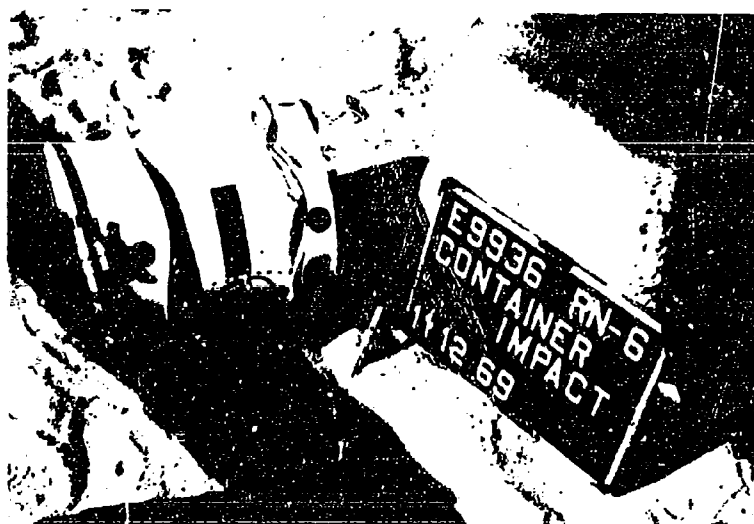
FIGURE 17. Typical Damage to the 1-gal System Bearing Impact on the Bottom.

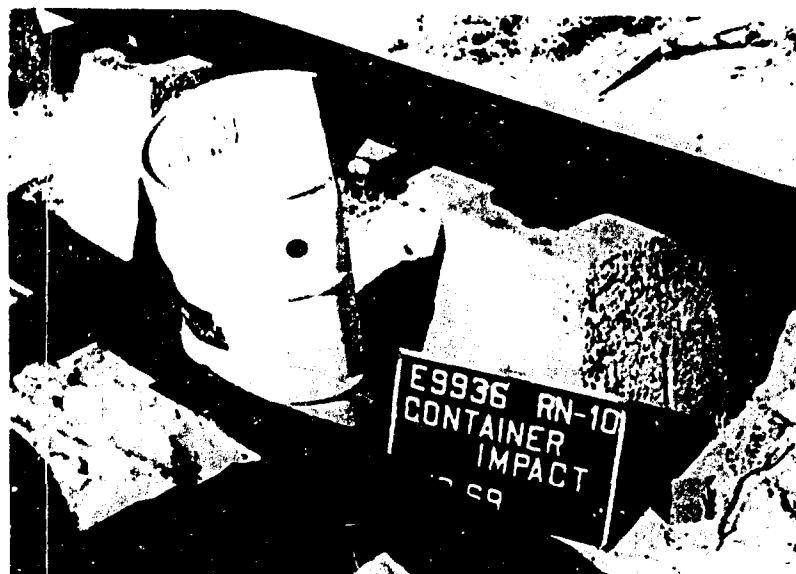
FIGURE 18. Typical Damage to the 5-gal System Bearing Impact on a Side.

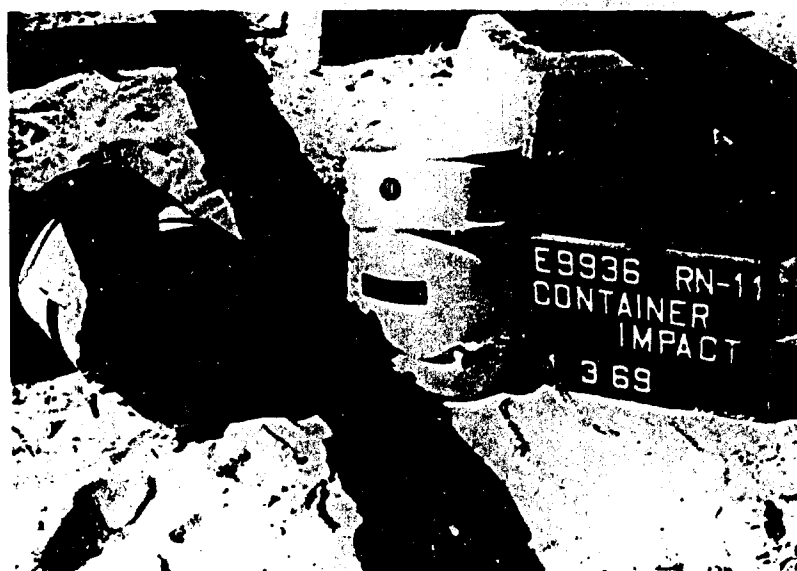
FIGURE 19. Test Run of Two 1-gal Systems Illustrating Shearing Effect of Target on Bolt Ring Closure.

A 3-inch clearance was provided for the rocket sled to pass under the target after impact. This imposed a shearing force 3 inches from the bottom of the test item (Fig. 19 and 23). It has been suggested that a full-face impact would be more desirable.

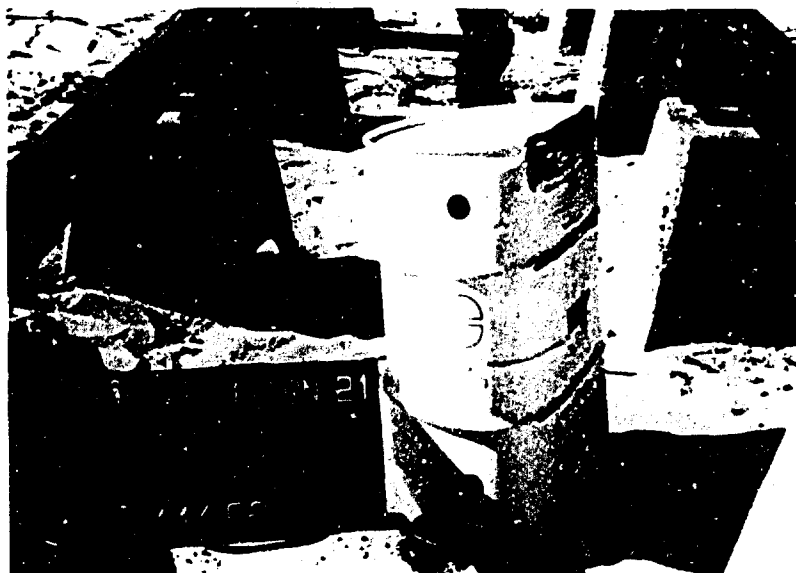
FIGURE 21. Full View of Impact Side Showing Typical Damage to the 5-gal System.

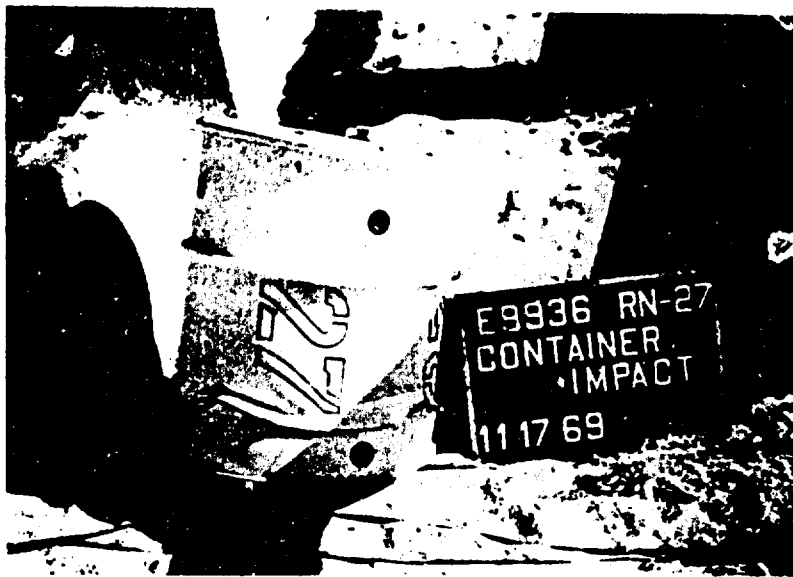
FIGURE 22. Typical Damage to the 5-gal System Bearing Impact on the Bottom.

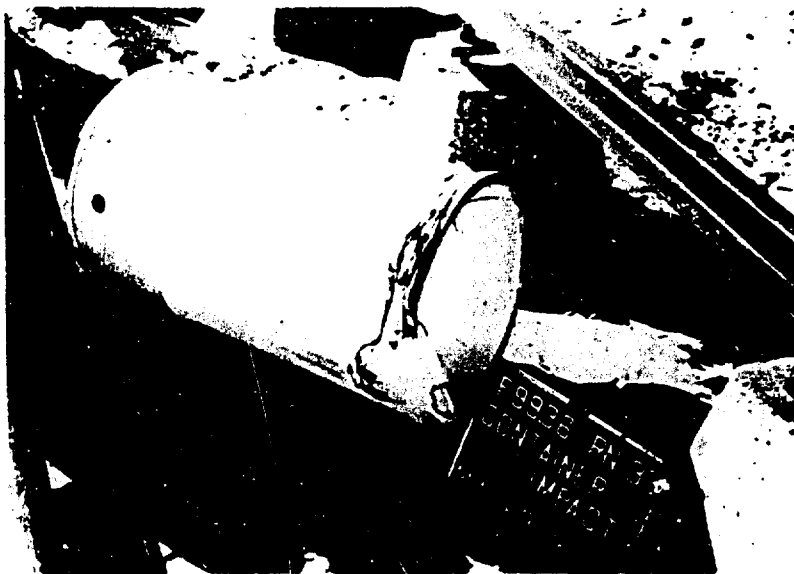
FIGURE 23. Fifteen-gallon System Impacted on Bottom.
